## Senior Canyon Tunnel Improvements Study

Senior Canyon Mutual Water  
Company (SCMWC)  
Ojai, CA

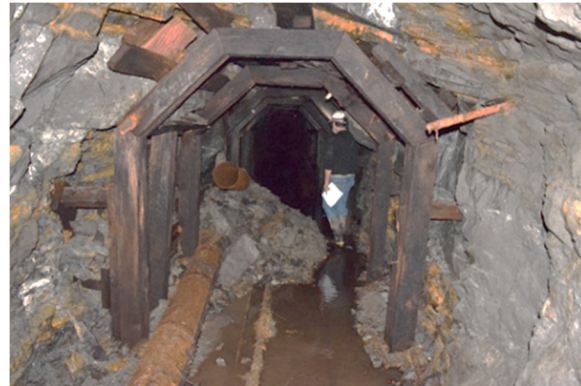
*Senior Canyon Tunnel Prior to Rehabilitation*
